The influence of structures on erosion of the north bank of the Mokihinui River mouth

Prepared for West Coast Regional Council

May 2019

NIWA CLIENT REPORT No: 2019103CH
Report date: May 2019
NIWA Project: ELF19504

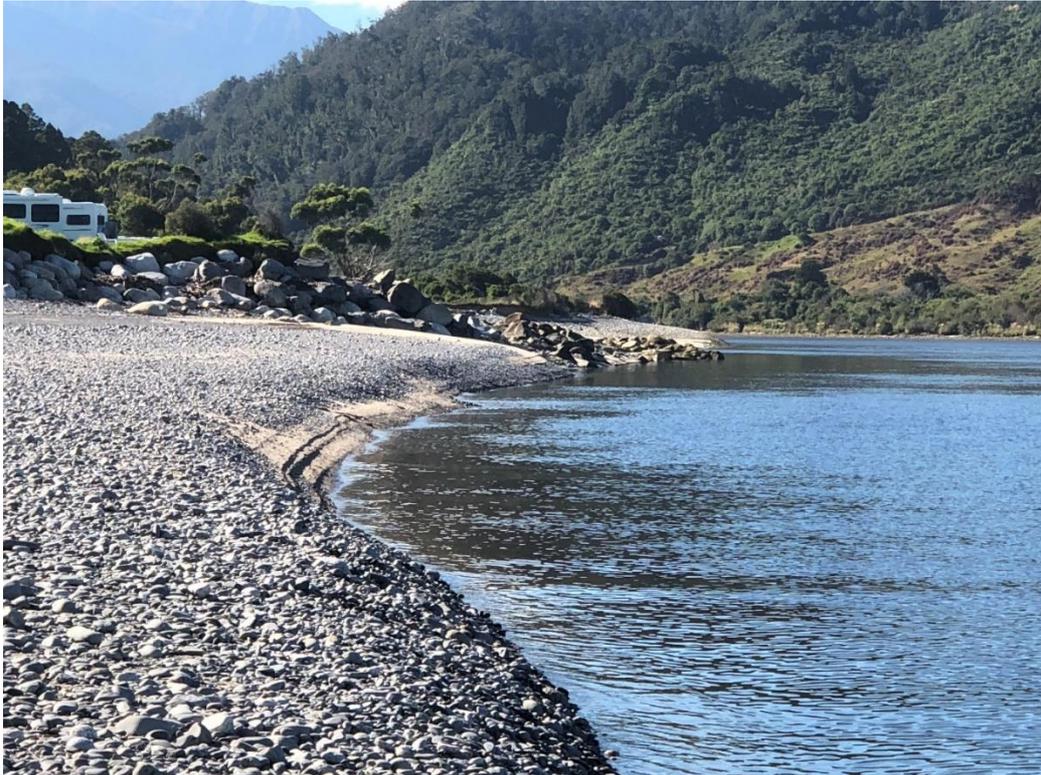
- The beaches adjacent to the river mouth appear to have abundant sand stocks (relative to my past observations over the period 2007-2010).
- The gneiss and granite boulder-grade road-verge protection at the elbow were collapsing down the bank (Figure 3-1), apparently due to undercutting by waves (because they face seaward and are sheltered from the river's current by the training wall just upstream).

Figure 3-1: View upstream on north bank to the root of the training wall. Rock riprap in front of campervans has partially collapsed.

A pragmatic solution would be to shift the road behind the Gentle Annie campground. The alternative mitigation is expensive rock protection.

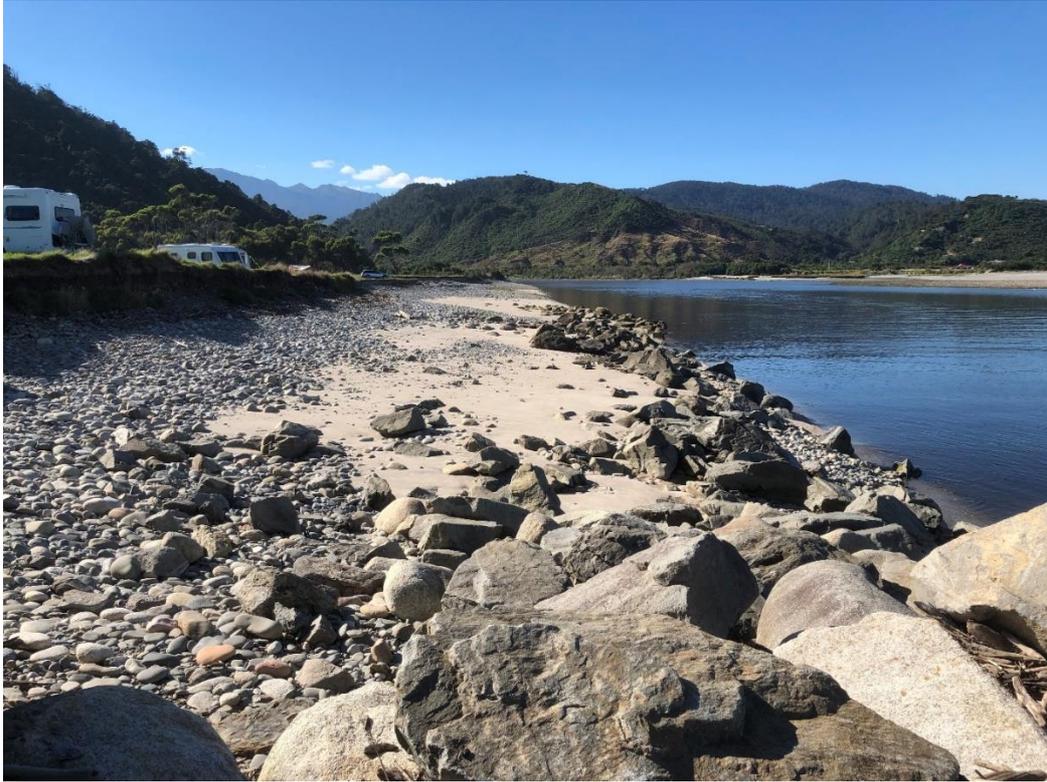
- Erosion embayment's occur in the north bank upstream from the remains of the north bank training wall (Figure 3-2); the erosion of the cobbly bank material has left a cobbly lag-beach in front of the bank which will be providing minor protection services; however, there is some danger that the remains of the training wall will soon be outflanked and isolated (like the upstream ends of the wall have been already).

- The river bank profile rises steeply from the channel bed (at about 40 degrees), then has a beach/berm up to 20 m wide before erosion scarps are encountered (Figure 2). The low tide channel bank-line is supported by the extended remnants of the north bank training wall (Figure 3-2), even if this is now submerged at high tide and flows. Thus, while direct river attack does not appear to be the mechanism by which the higher segments of bank are being eroded, the river will be helping clear the eroded material and it remains forced alongside the north bank.

Figure 3-2: View upstream on north bank along remnants of training wall.

Removing the riprap from the remnants of the north bank training wall would likely exacerbate the north bank erosion. This is because this material still provides some bank-stabilising function.

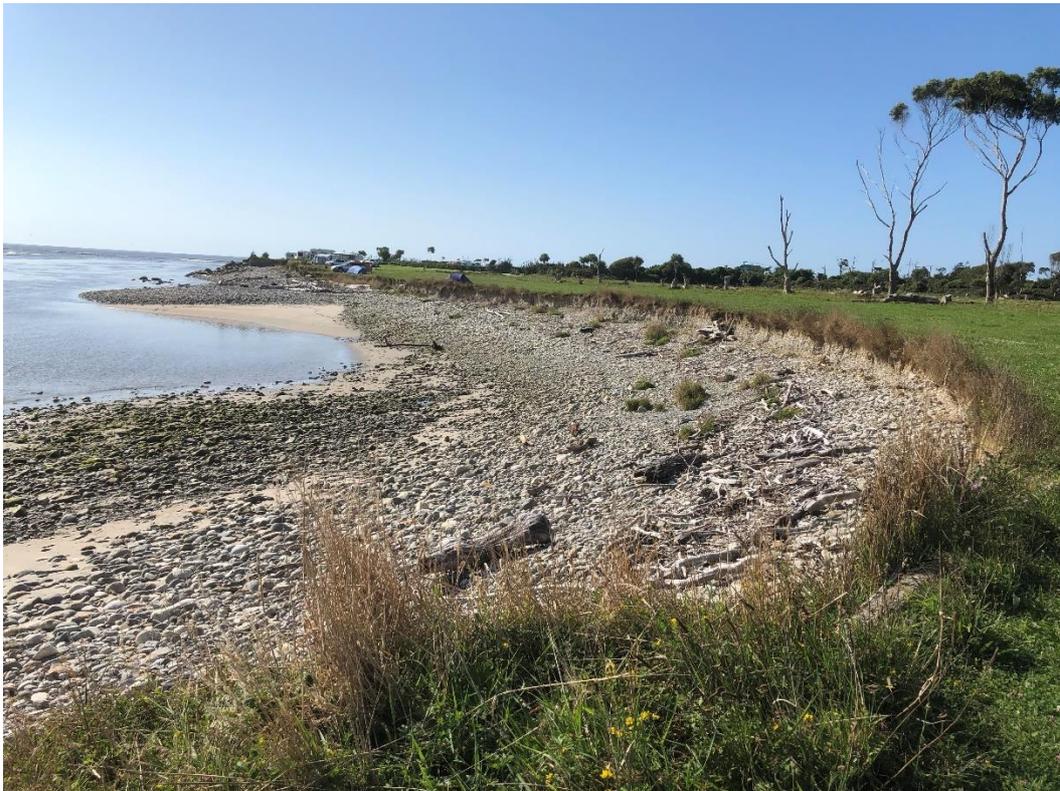
- The erosion seaward of the two stub groynes appears relatively recent (Figure 3-3), but the erosion upstream appears to be older, as evident by vegetation grown over the erosion scarp (Figure 3-4).

Figure 3-3: View seaward on north bank, showing relatively recent erosion “bite” into cobbly terrace fronted by cobble lag beach.

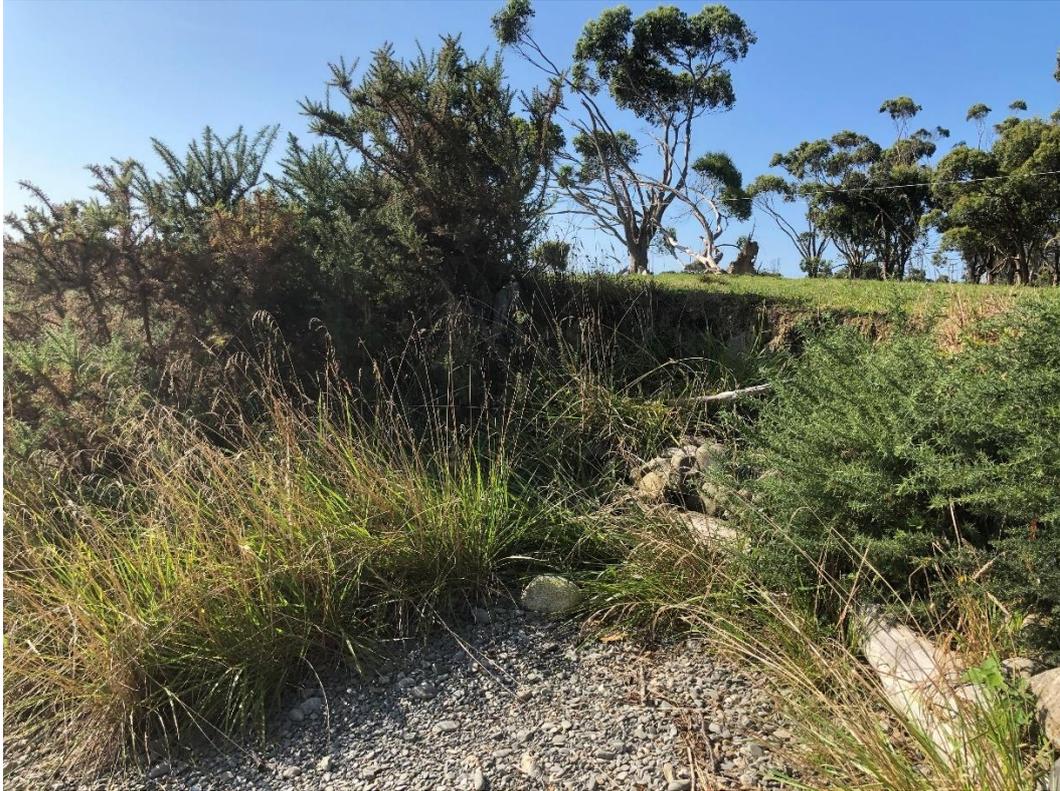
Figure 3-4: Close-up of vegetated-over erosion scarp between north bank stub groynes.

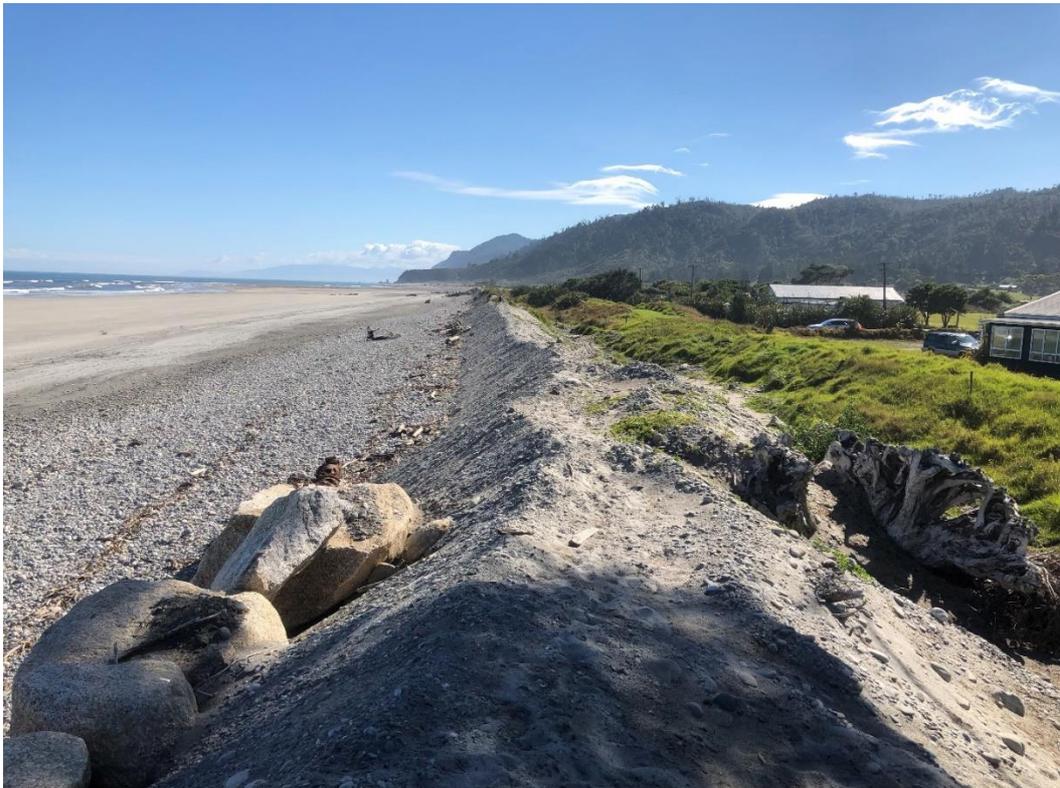
- The seaward bund is composed of gravelly sand scraped from the upper beach. Its face is steep, and around the access point at the end of Lewis Street it is at the repose angle, showing that it is being "chewed" by waves at high tide (Figure 3-5). The upper foreshore is formed by a narrow ramp of cobbles, while the mid-lower foreshore is wide and sandy.
- The four rock spur groynes (~ 10m long spur, ~ 20 m long base) keyed into the seaward bund appear to be having minor/minimal effects. I saw no sign of any sand/gravel impoundment wedge adjacent to the southern spur groyne (near the macrocarpa trees; Figure 3-6), but there was a narrow upper foreshore gravel wedge between the 2nd and 3rd spur groynes and between the 4th spur groyne and the spit-tip

Figure 3-5: Double bund fronting Mokihinui township. Note steep (at angle-of-repose) seaward face of seaward bund, cobble ramp on upper foreshore, and wide sandy lower foreshore.

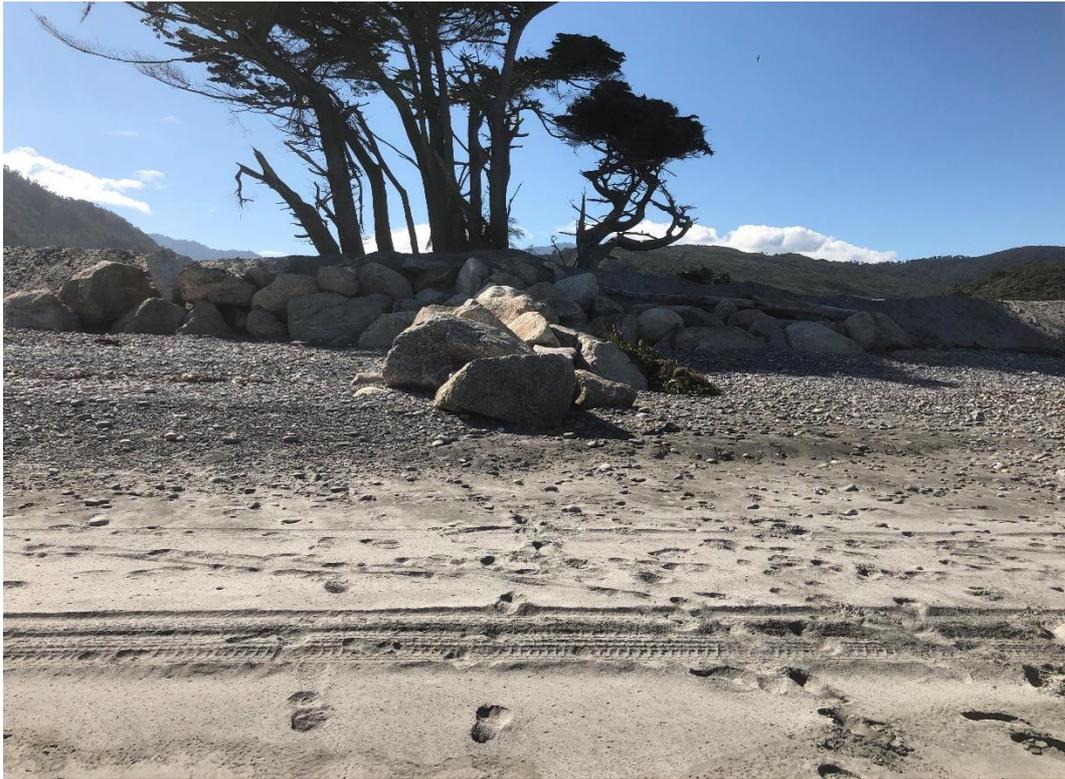
Figure 3-6: The spur groyne south of Lewis Street. Note no difference in width of cobble ramp either side.

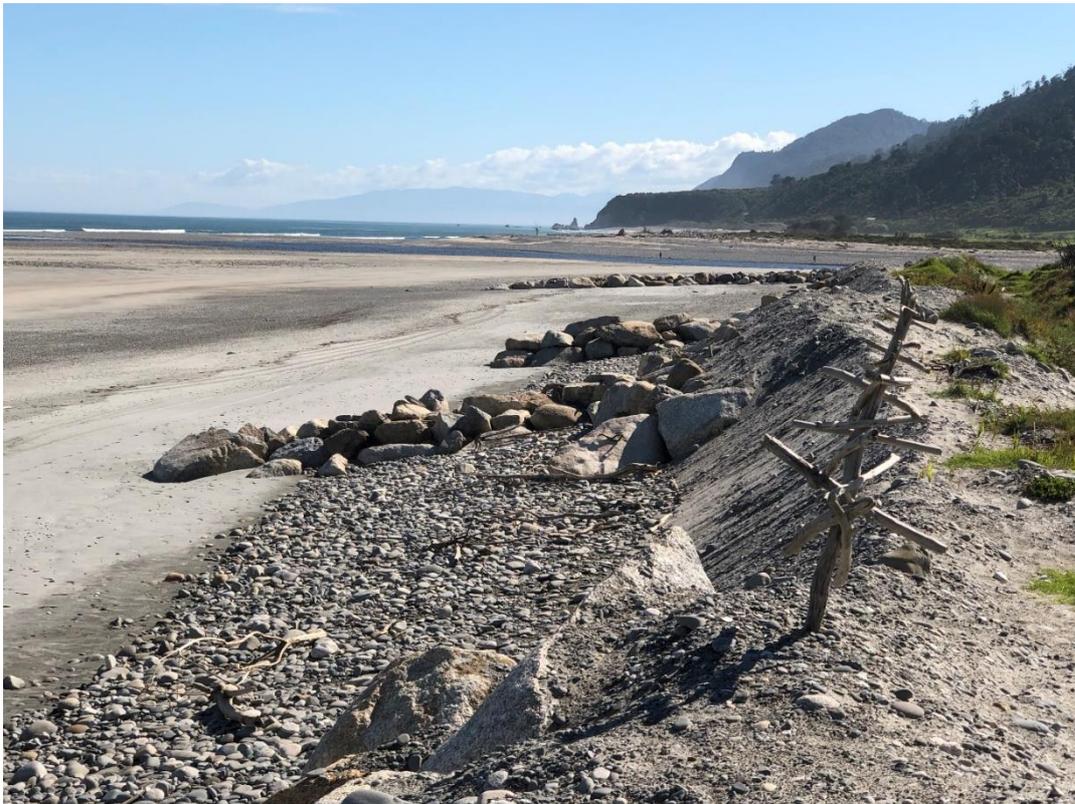
groyne (Figure 3-7). The wedge orientation indicated northward transport, as expected, but the “thick end” width was only several m, so the protective services developed will be minimal. Thus, these spur groynes appear to be too short to have any significant effect.

Figure 3-7: The 3rd and 4th stub groynes and the spit-tip groyne in the background. Note northward thickening of cobble ramp towards the nearest (3rd) groyne.

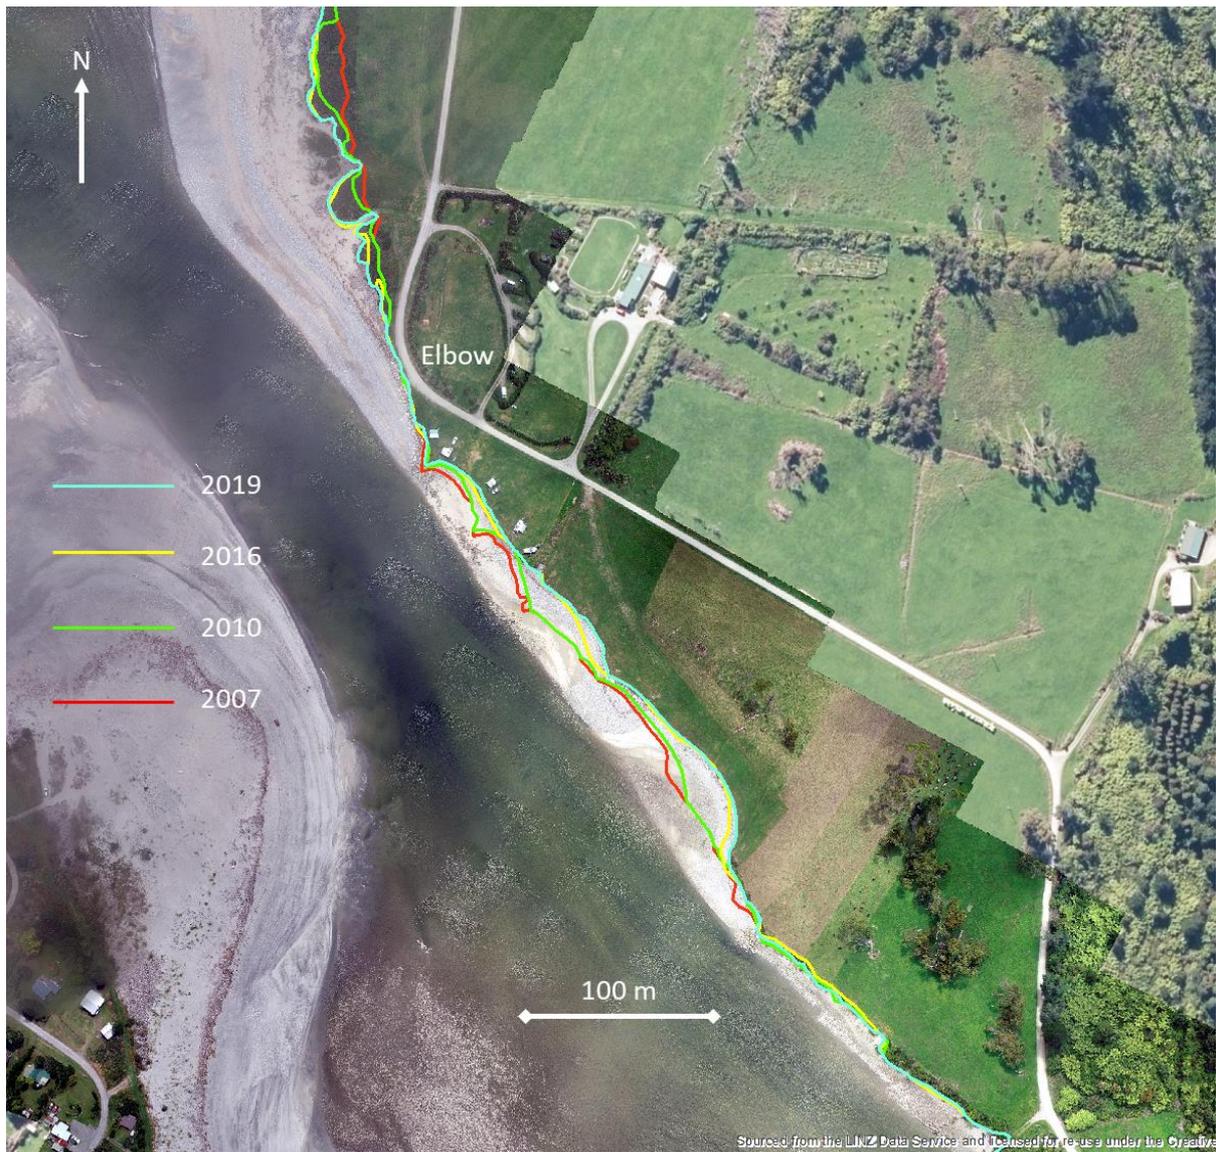
Finer details of the recent positions of the north bank are shown on Figure 4-2. On this, bank positions were mapped from georeferenced vertical aerial photographs taken in 2007, 2010, 2016, and February 2019. This shows an overall bank retreat of up to 21 m along the ~ 300 span of bank upstream from the 'elbow' between 2007 and 2019, but with most of this occurring between 2010 and 2016 (which included the two largest recent floods of late 2010 and late 2011) and a lesser amount between 2007 and 2010. The bank retreat shows a 'cusped' pattern, with retreat greater in shallow embayment's between cobbly headlands (similar to the pattern observed on cusped gravel beaches). Less overall retreat occurred between 2016 and 2019 (which includes Cyclones Fehi and Gita in February 2018), but 2-8 m of retreat over this period was focussed on WSW-facing banks on the seaward sides of the cusps – which suggests erosion by waves rather than high river flows.

Further upstream, the 170 m span of bank enclosed by the two stub groynes has remained stable since 2010 (within the 1-2 m level of detection afforded by the aerial imagery).

Seaward of the elbow, the bank (or at least the vegetation edge) has advanced up to about 20 m since 2007.

Figure 4-2: North bank locations between 2007 and 2019 overlaid on 2019 imagery. Bank/shore edge positions mapped off edge of vegetation on georeferenced imagery.

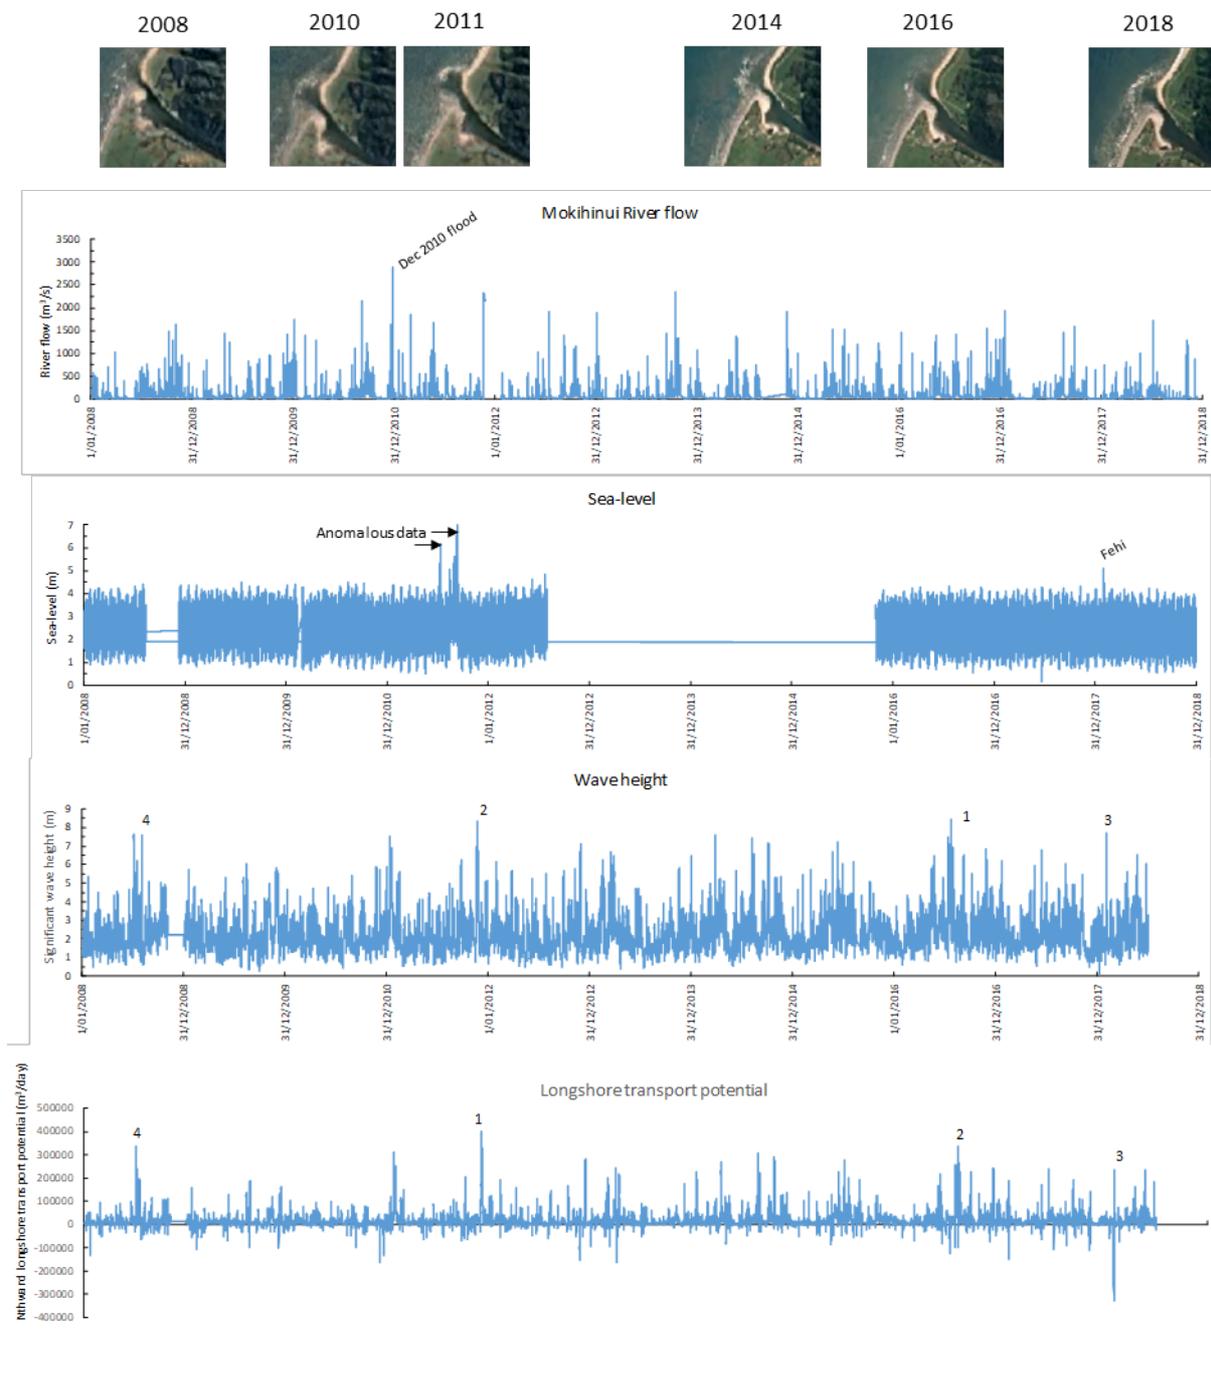
The largest river flood (peaking at 2875 m³/s) occurred in December 2010. Note on the 2010 and 2011 images at the top of Figure 6-1 how the sand “bulge” on the south side of the river mouth was largely trimmed off after this flood (but built back in subsequent years).

The highest sea level of recent years (~ 1.5 m above normal high tides) was the storm surge associated with Cyclone Fehi on 31 January 2018⁷. Fehi also provided the 3rd highest wave event since 2008, and so was the likely cause of the most recent erosion on the northern river bank (attack from seaward was also indicated by the westward aspect of the erosion “bites”). Higher wave events occurring in November 2011 and July 2016 (but with less storm surge) might account for the erosion recorded between 2010 and 2016.

Figure 6-1: River flow, sea level, significant wave height, and longshore transport potential at Mokihinui since 2008. River mouth images from Earthengine shown at top. Numbers 1-4 on wave height and longshore transport potential plots rank the four largest events. The 28 December 2010 river flood peaked at 2875 m³/s.

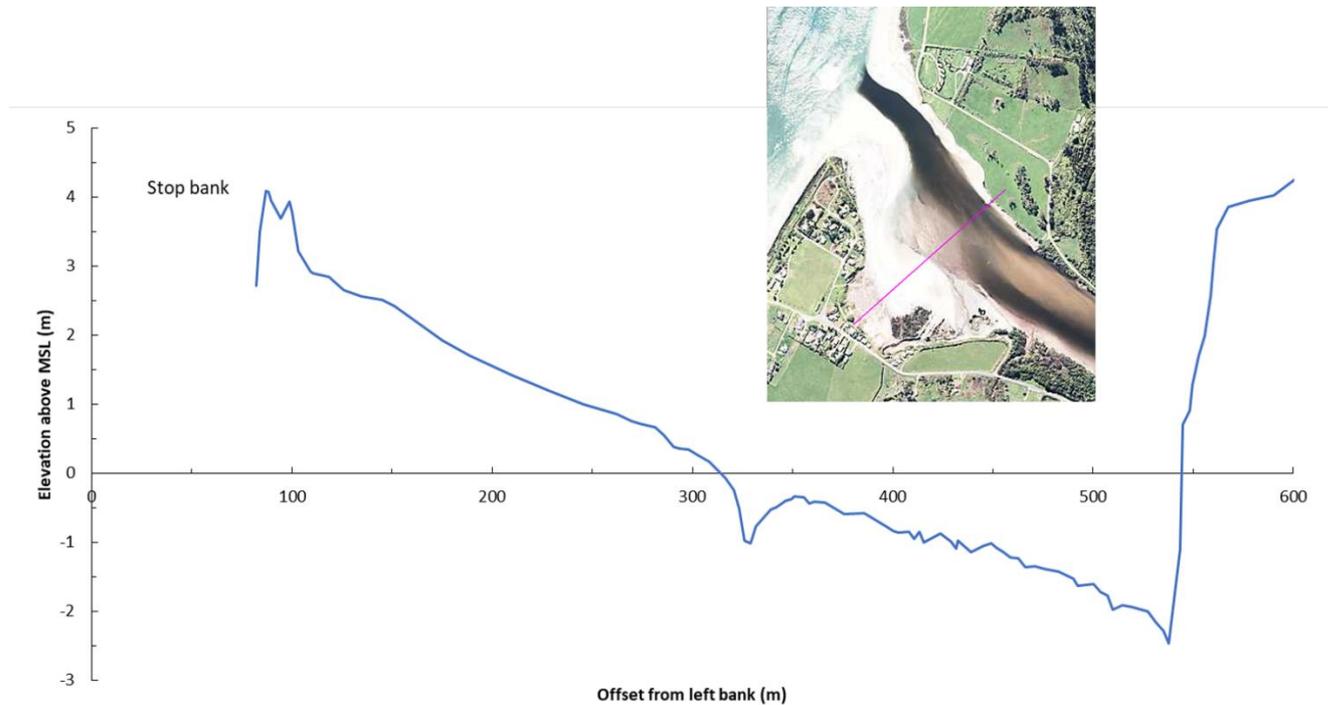
A further piece of useful information is an estuary cross-section that was surveyed by NIWA during the Mokihinui hydro-power investigations (Figure 7-1). This was surveyed in February 2011, shortly after the large flood of December 2010, and shows the channel midway down the estuary having an asymmetric shape, with the thalweg hard against the steep right bank. This provides evidence of the effectiveness of the left bank training wall at deflecting flood momentum along the north bank.

Figure 7-1: Mokihinui cross-section surveyed in February 2011. Section located by pink line on inset image. Wet part of channel surveyed by echo-sounder linked to RTK-GPS; dry parts from prior LiDAR survey. Source: NIWA.
