## **Poplars and willows as bioengineering solutions for riverbank flood protection – learnings from Cyclone Gabrielle**

Mclvor I, Heslop I, Brooks F

June 2024

River Managers' Special Interest Group  
Te Uru Kahika – Regional and Unitary Councils Aotearoa

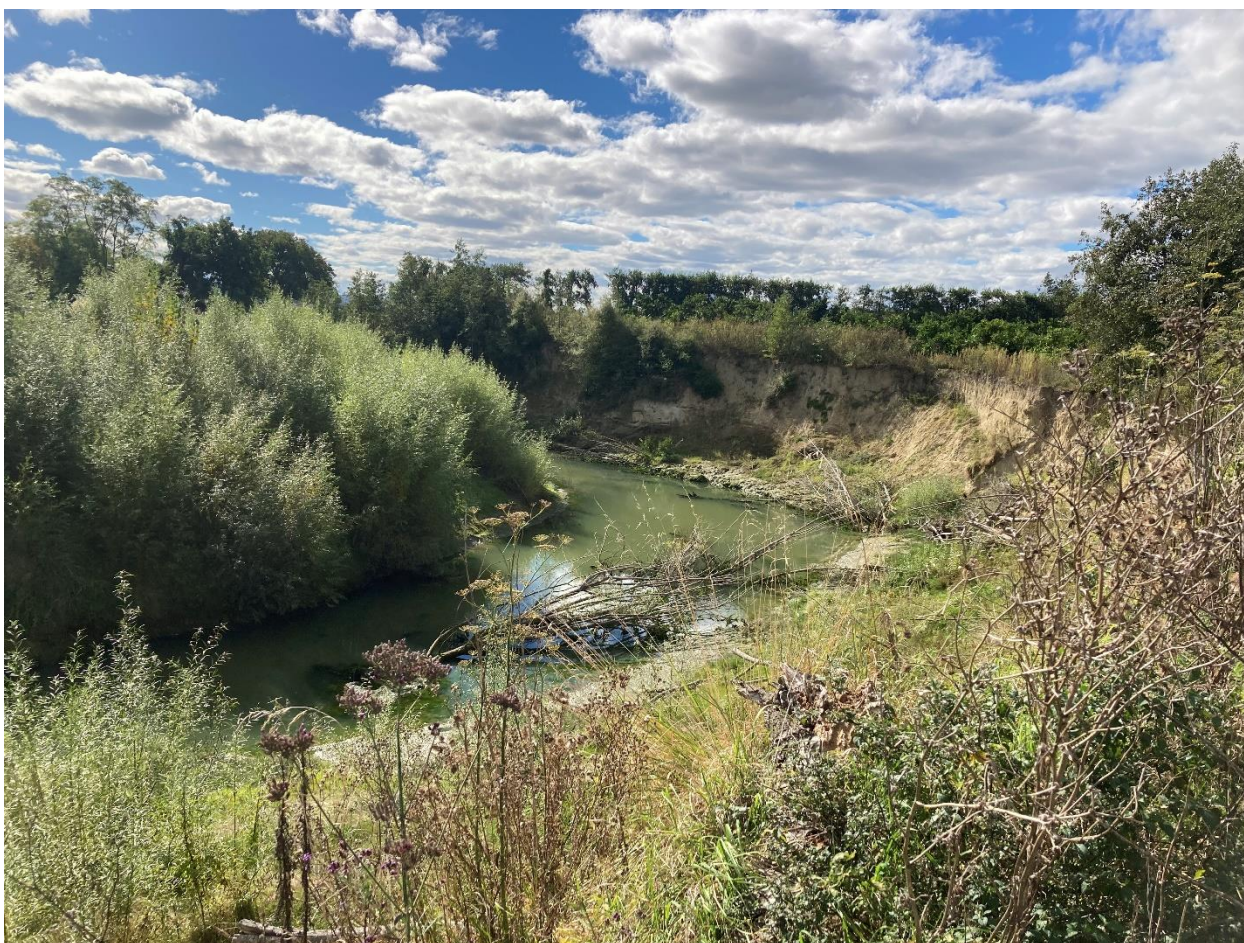
**Figure 23.** Erosion of the bank on an outside bend, Te Ārai River. Heavily wooded inside bend traps sediment and narrows the channel.

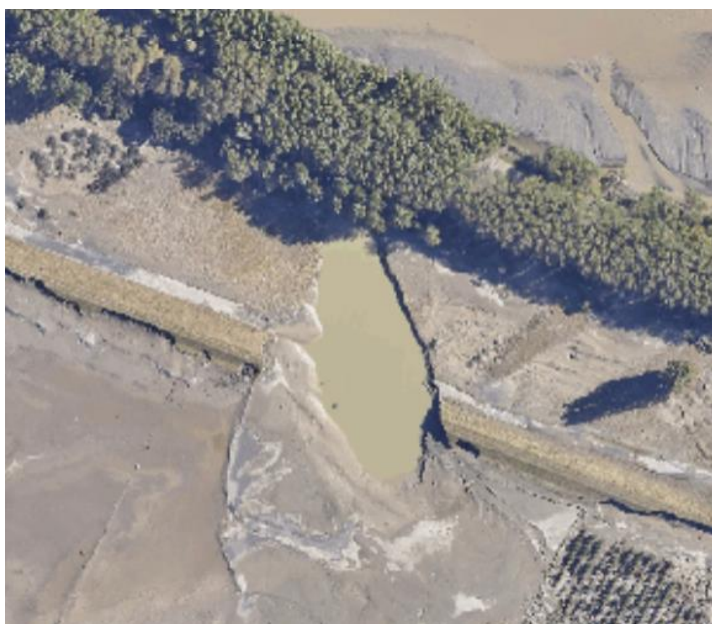
**Figure A15.** Moteo stopbank breach – berm scour arrested by buffer zone.

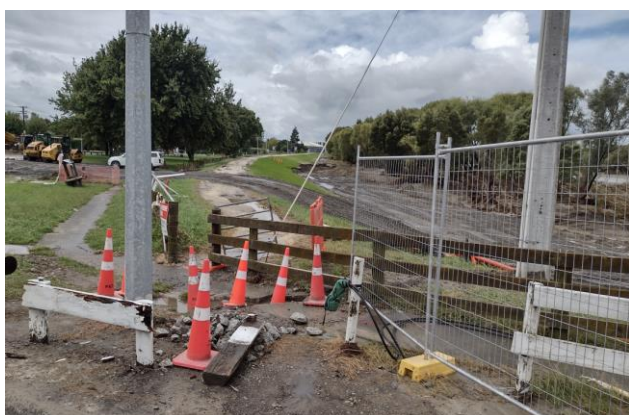
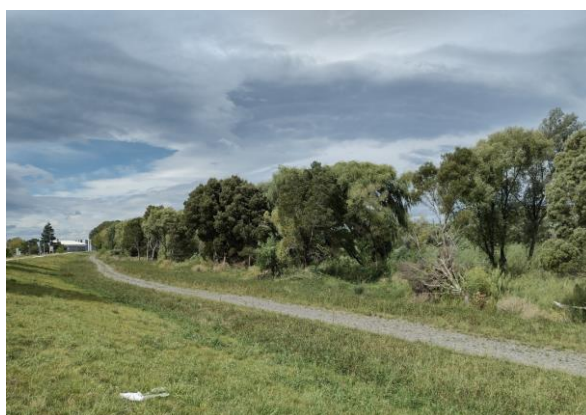
**Figure A21.** Berm erosion alongside Taradale stopbank (left). Taradale stopbank – post-cyclone berm repairs (right).

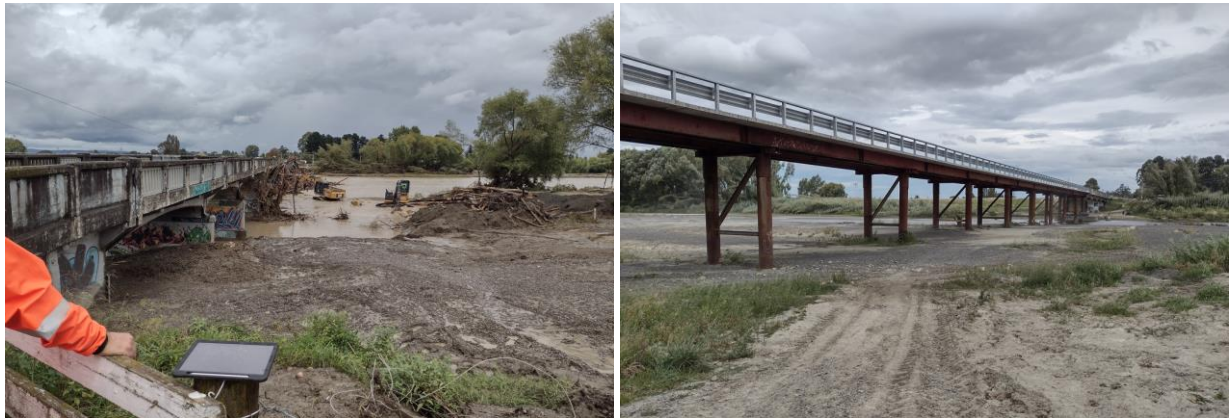
**Figure A22.** Redclyffe Bridge – cyclone debris removal (left). Redclyffe Bridge – interim repairs (right).

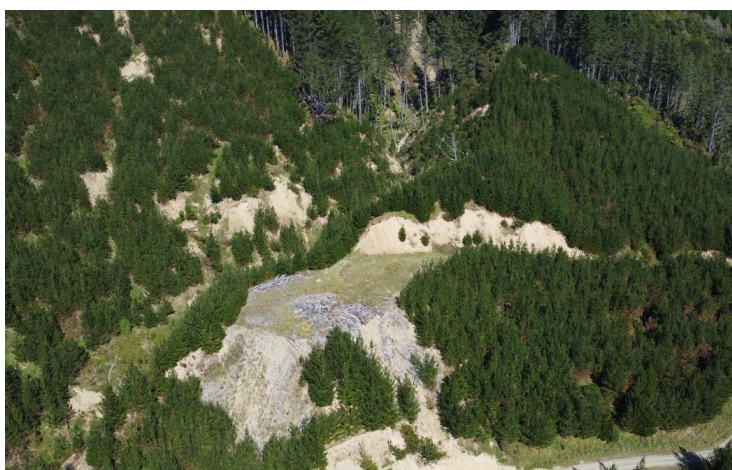
**Figure A25.** Forestry landing and woody waste pile undermining – Hikuwai catchment.
