The influence of structures on erosion of the north bank of the Mokihinui River mouth

Prepared for West Coast Regional Council

May 2019

NIWA CLIENT REPORT No: 2019103CH
Report date: May 2019
NIWA Project: ELF19504

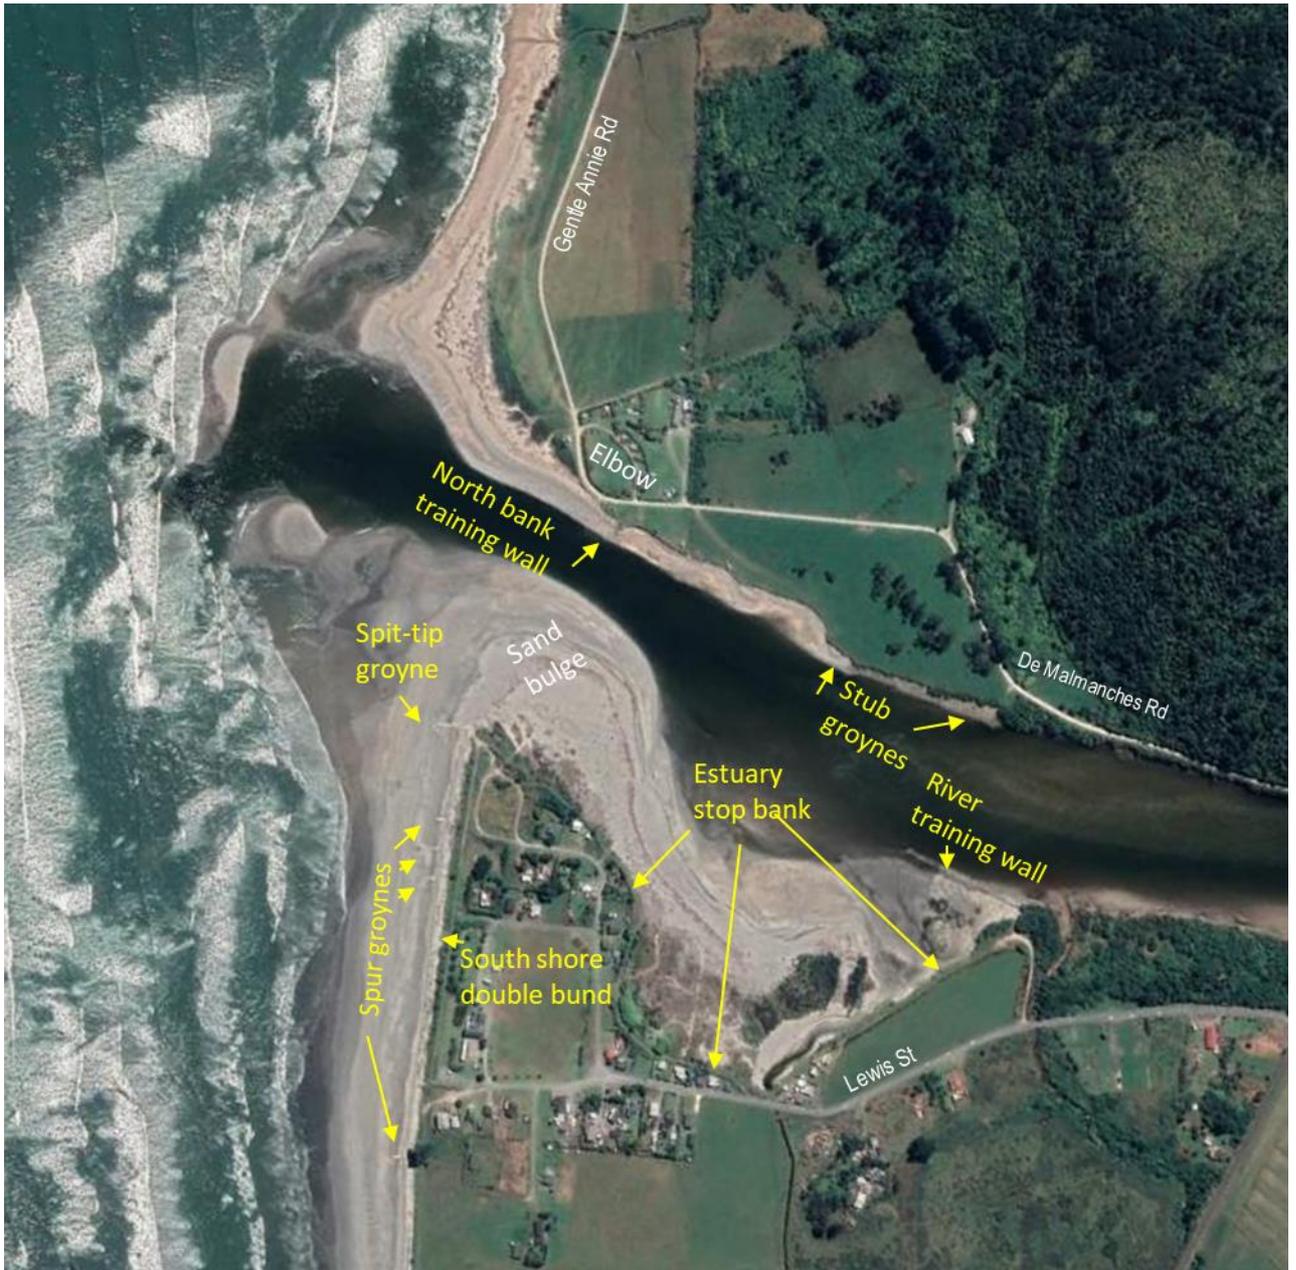
Figure 2-1: Photo-map locating structures at Mokihinui River mouth. Image from Google Earth (photographed 2018).

- The spit-tip groyne, while extending 40 m across the mid-upper foreshore, is a small feature at the river mouth scale (Figure 2-1) and is too short to trap much sand – since longshore transport occurs in the surfzone which is only partly penetrated by this feature even at high tide. Thus, while it will be having a small local effect, sand will largely be bypassing it.

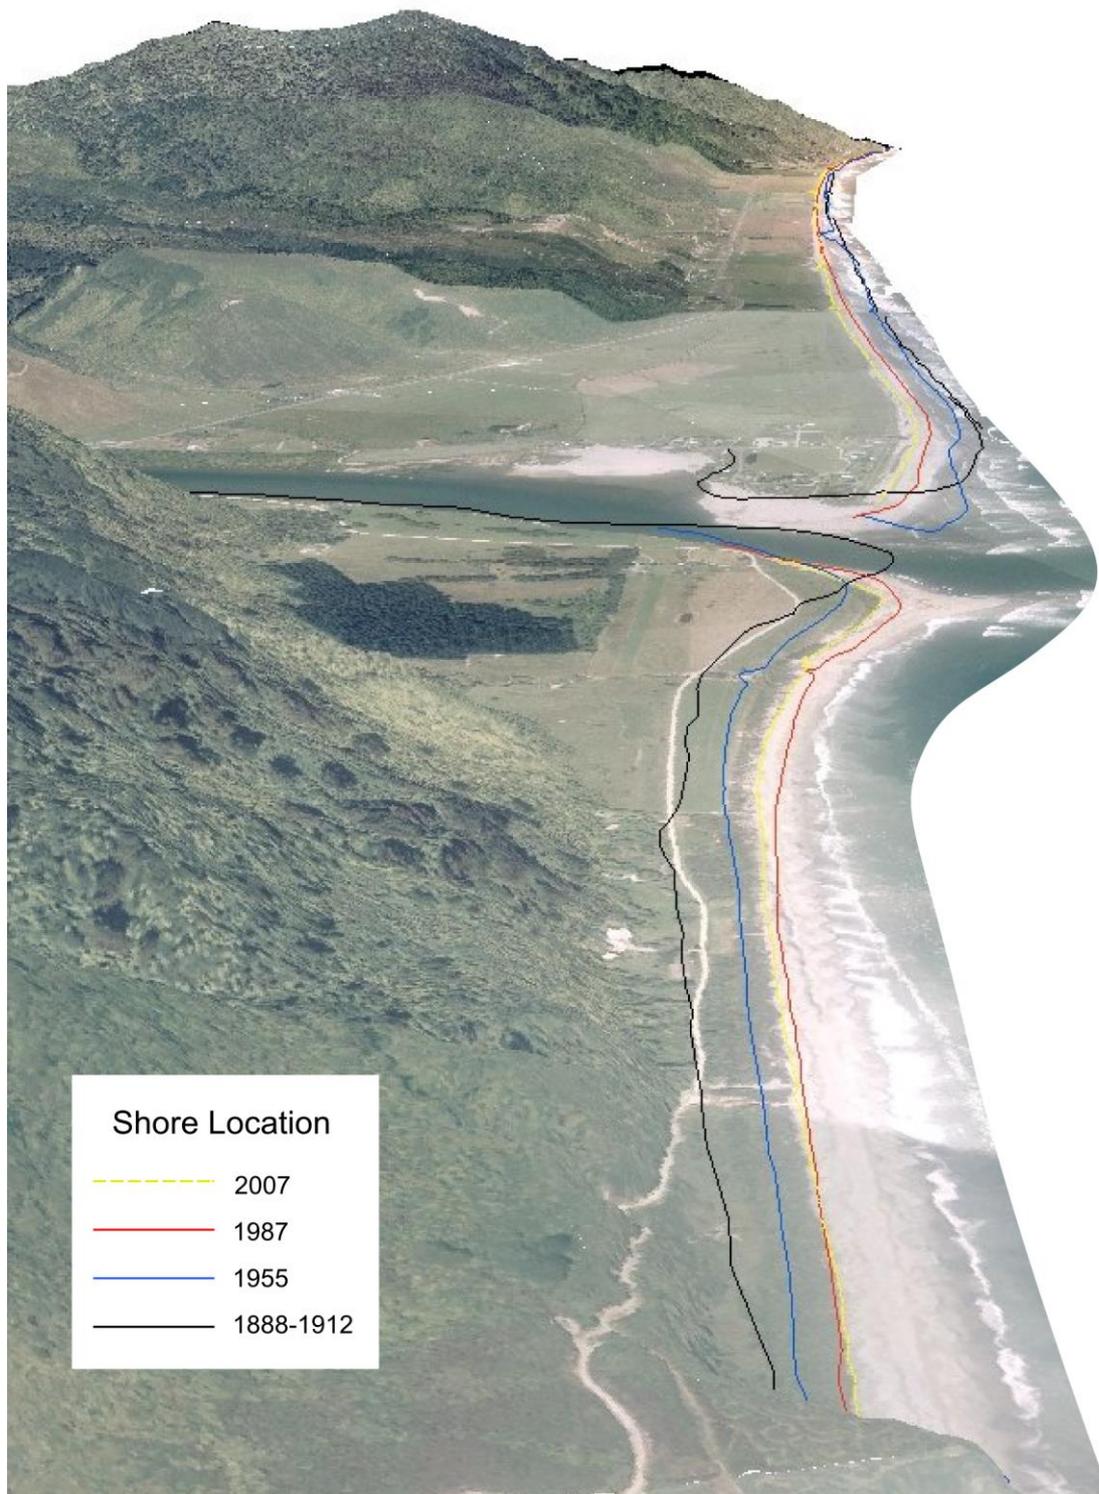
Historical shoreline positions along the Mokihinui embayment, from the late 1800s to 2007, were mapped by Hicks et al. (2007) as part of Meridian Energy's investigations around effects of the proposed Mokihinui hydro project (Figure 4-1). These showed that north of the Mokihinui River the shoreline built seaward between 1906 and 1987 but then retreated. The 1906 cadastral shore/bank line shows that the river outflow then was more normal to the general shoreline trend (i.e., the river flowed straight out to sea), but since around 1955 the outflow has deflected north, with up to ~150 m of erosion off the north bank before 2007. South of the river, the shoreline has experienced ongoing retreat since the first cadastral survey in 1898, with rates increasing after 1955 (from 0.5 m/yr to over 1 m/yr). Shoreline recession rates taper-off with distance north and south of the river.

Figure 4-1: Panorama view south from Gentle Annie, showing historical shoreline positions overlaid on 2007 image. From Hicks et al. (2007).

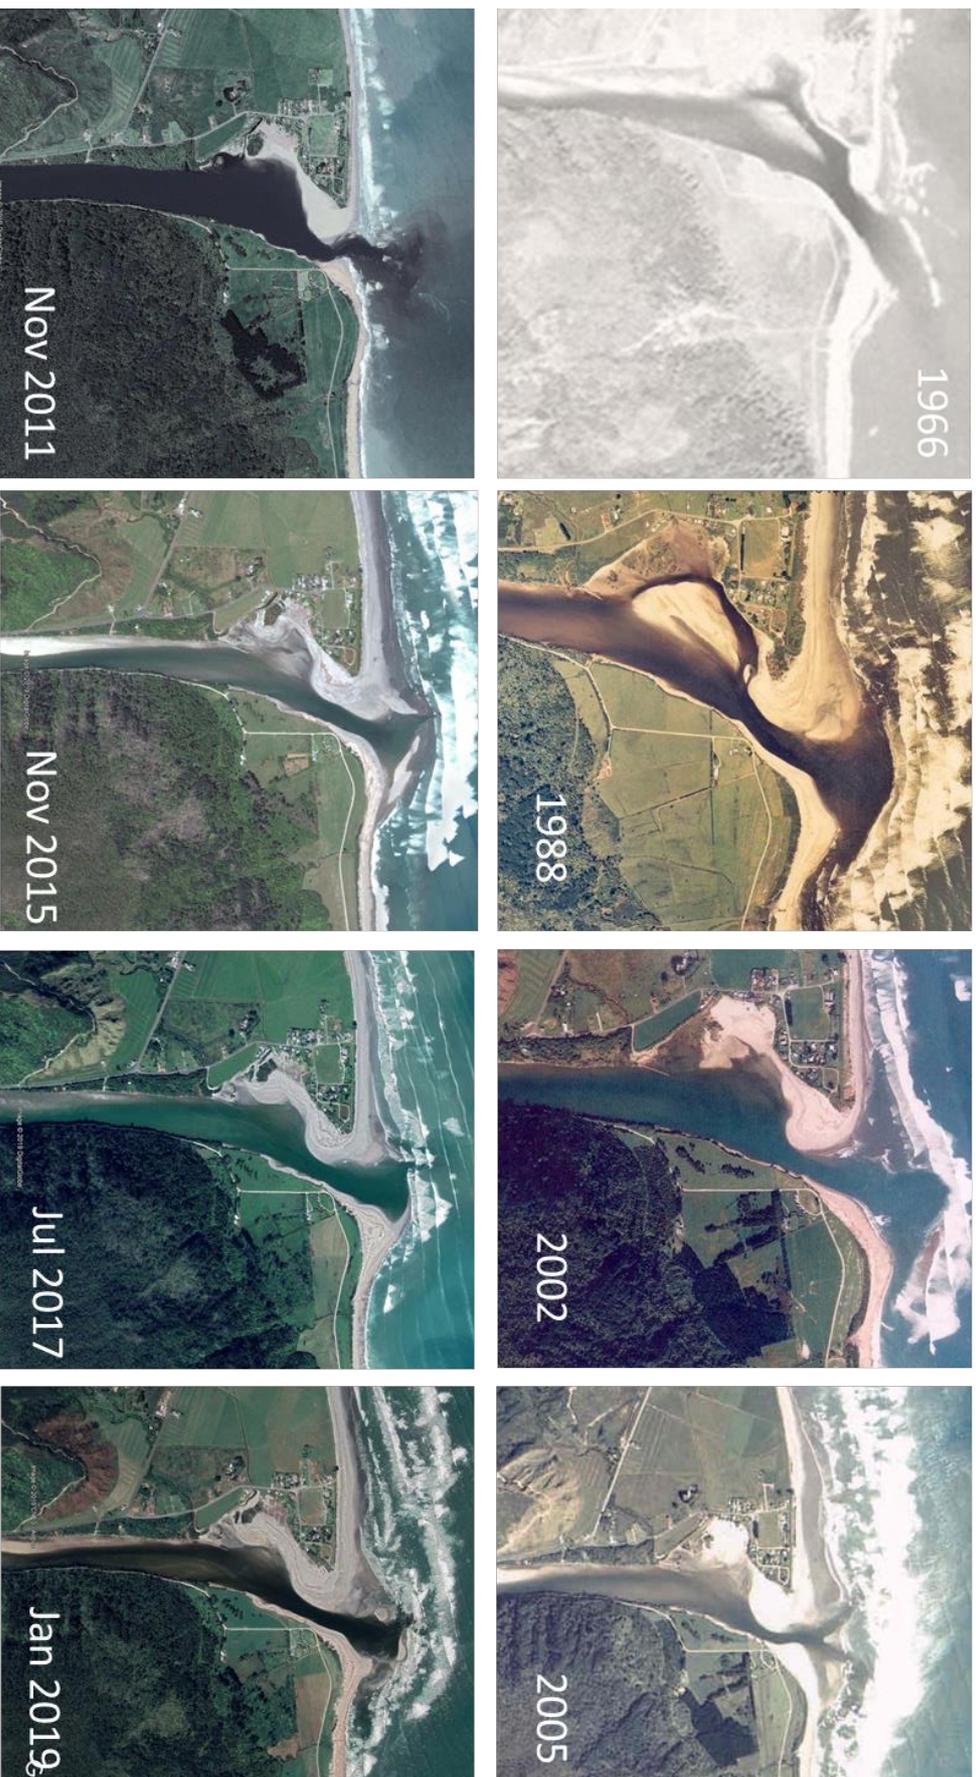
Figure 5-1 shows little change to the basic river mouth pattern since the 1960s, with the river mouth consistently deflecting north of the centreline and a spit (or shoreline bulge) always present on the southern bank. More detailed time-series imagery extracted from Earthengine² over the period 2008-2018 shows that the spit waxes and wanes in size, forcing the river more or less towards the north bank, while the outflow across the Rivermouth bar “thrashes around” over an arc of about 40 degrees. The 1966 photograph (Figure 5-1) appears to have the greatest northward deflection, and this concurs with comments made in 1972 that “the present outlet which is well to the north of the township and is resulting in a loss of effective head to the sea”³. The construction of the north bank training wall in 1978 would have restricted this northward deflection tendency.

Figure 5-1: Aerial photographs of the Mokihinui River mouth from 1966 to January 2019. 2011-2019 imagery from Google Earth.
