## **Poplars and willows as bioengineering solutions for riverbank flood protection – learnings from Cyclone Gabrielle**

Mclvor I, Heslop I, Brooks F

June 2024

River Managers' Special Interest Group  
Te Uru Kahika – Regional and Unitary Councils Aotearoa

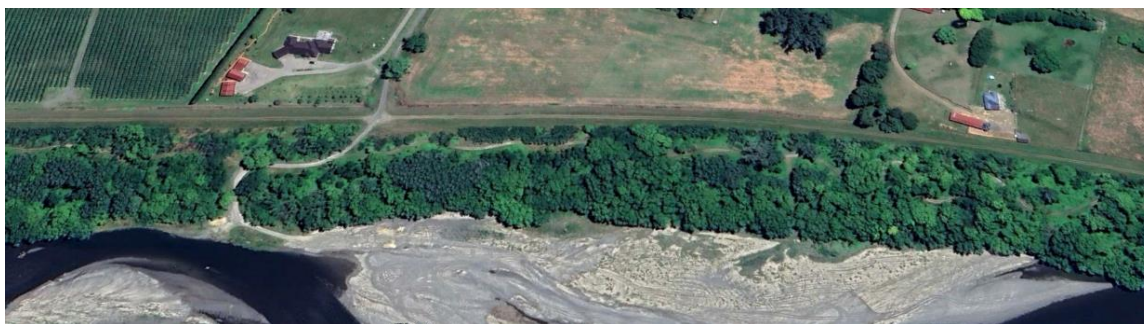
**Figure 8.** Pre-Gabrielle; Dec 2021.

An example of riverbank protection is the mid-Dartmoor site (refer Appendix 2) located on the true left bank opposite lower Ebbetts. The pre-cyclone riverbank and berm plantings consisted mainly of large to medium size tree willows, actively managed by lopping and layering. In addition to rope and rail training lines along the river edge, the berm included groynes to improve resistance to bank erosion.

The stopbank was set back 70 m from the riverbank, and most of the berm width was planted, which in normal floods would offer erosion protection to the stopbank. However, the cyclone flows significantly exceeded the floodway capacity, and the adjacent stopbank overflowed and breached. The siphoning-off of large breach flows from the main channel, combined with the directional effects of Ebbetts floodplain return flows, combined to wash out or flatten the berm planting. Fortunately, the river channel alignment held due to the combination of bank and berm erosion protection measures in place. The post-cyclone aerals showed partial regrowth of the poplars and willows flattened by floodwaters, which demonstrates the durability of the remnant erosion protection planting. The aerial photos below (Figures 8 & 9) show the pre- and post-cyclone riverbank and berm protection planting.

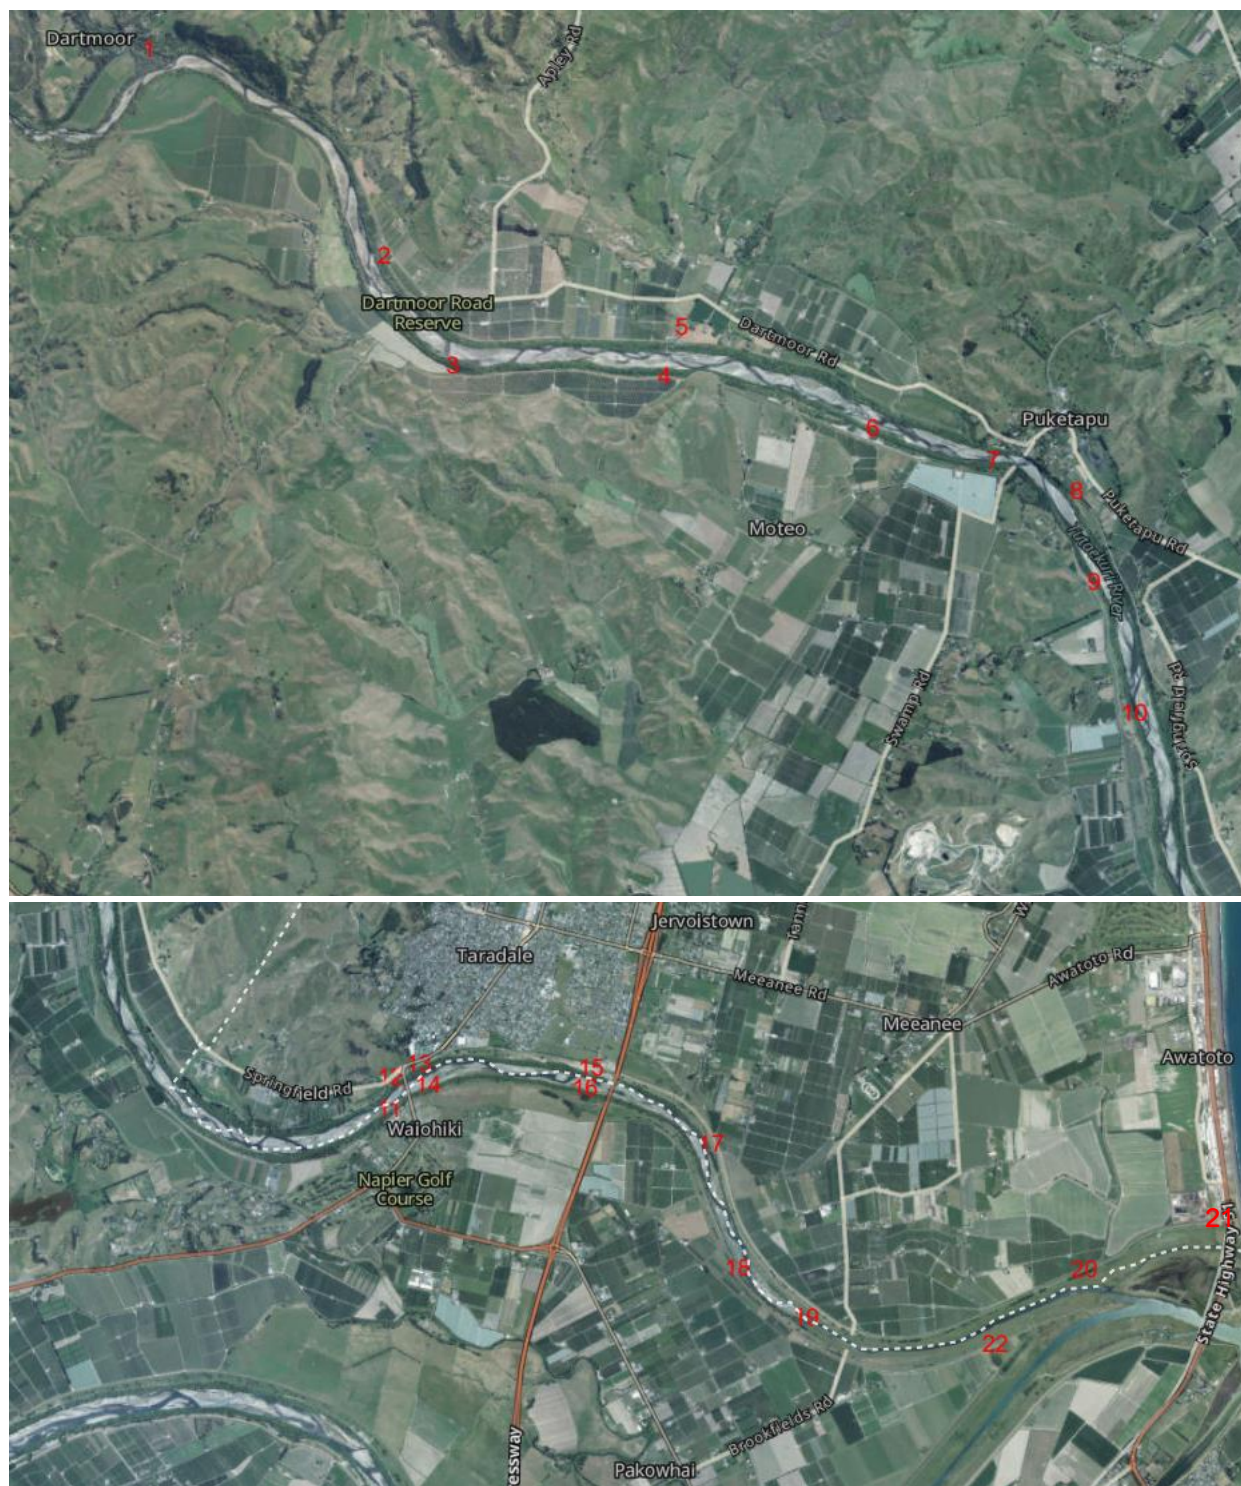
We visited sites on the river (Table 1, Figure 10) where there was significant damage due to erosion or undermining of banks, overflows of channels and berms, stopbank breaches, and substantial outflows onto floodplains. There was significant deposition of woody debris and sediment associated with this. On the whole the bioengineering assets (bank, berm, and buffer zone plantings) performed well. However, in localised areas where stopbanks breached, or overflows onto berms and floodplain areas were concentrated, the bioengineering assets partially or completely failed.

**Figure 10.** Inspection sites.

Floodwaters damaged bank and berm plantings at several locations, e.g. confluence with the Mangaone River (site 1), Dartmoor Road Reserve (site 2), Ebbetts upstream (site 3); damaged bank and berm plantings as well as breaching stopbanks at Ebbetts downstream (site 4), mid-Dartmoor (site 5), Moteo (sites 6 & 7), Puketapu (site 8), Omaranui (sites 9 & 10); and breached stopbanks with minimal planting damage at Pakowhai (site 22) and Waitangi/Awatoto (site 21).

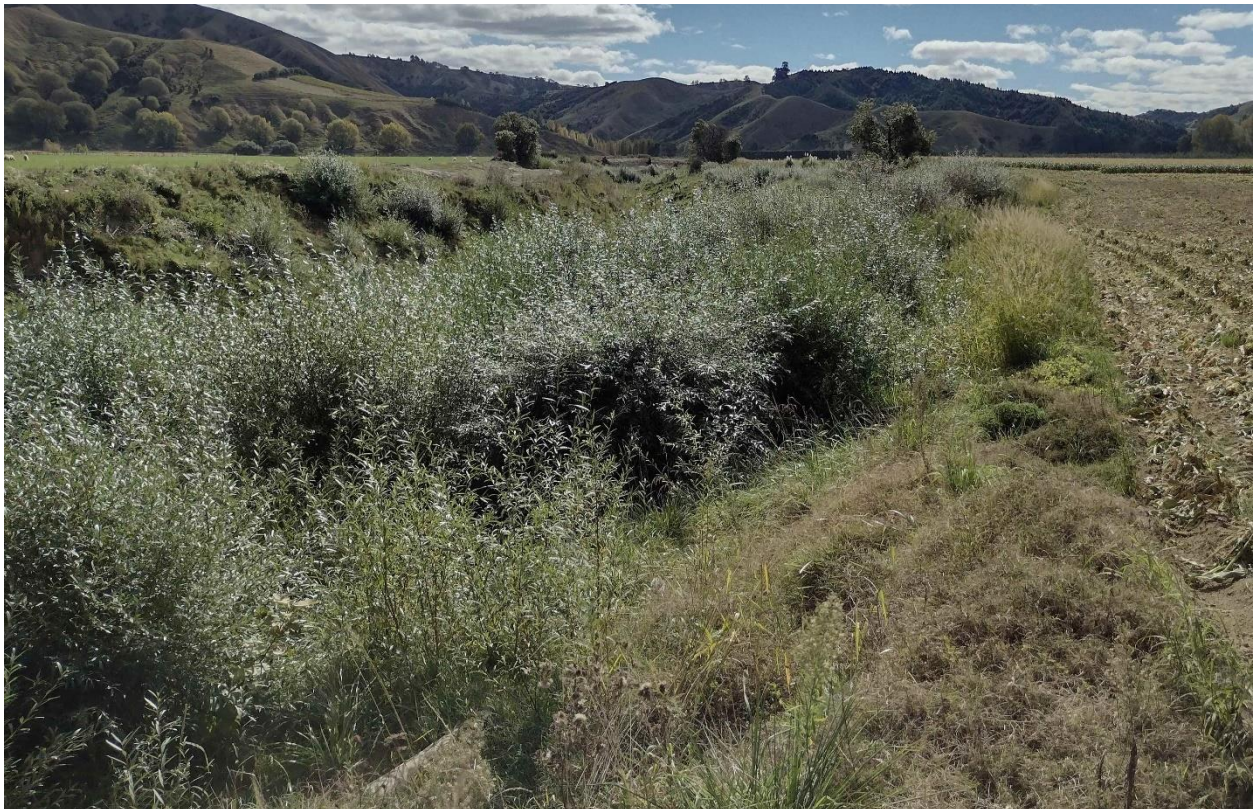
Except for a few sites, the river edges and bank were intact and protected by mature woody vegetation (Figure 21). Woody debris trapped in the channel had been removed, and the woody vegetation (largely osier willow) had been coppiced (Figure 22). Eroded outside bends had not yet been re-stabilised (Figure 23). There was no evidence of trees being flattened by floodwaters as noted on the Tūtaekurī River. This was no doubt attributable to the lower gradient and flood velocities in the Te Ārai River.

**Figure 21.** Typical bank vegetation on downstream Te Ārai River with dense osier willow on near bank.

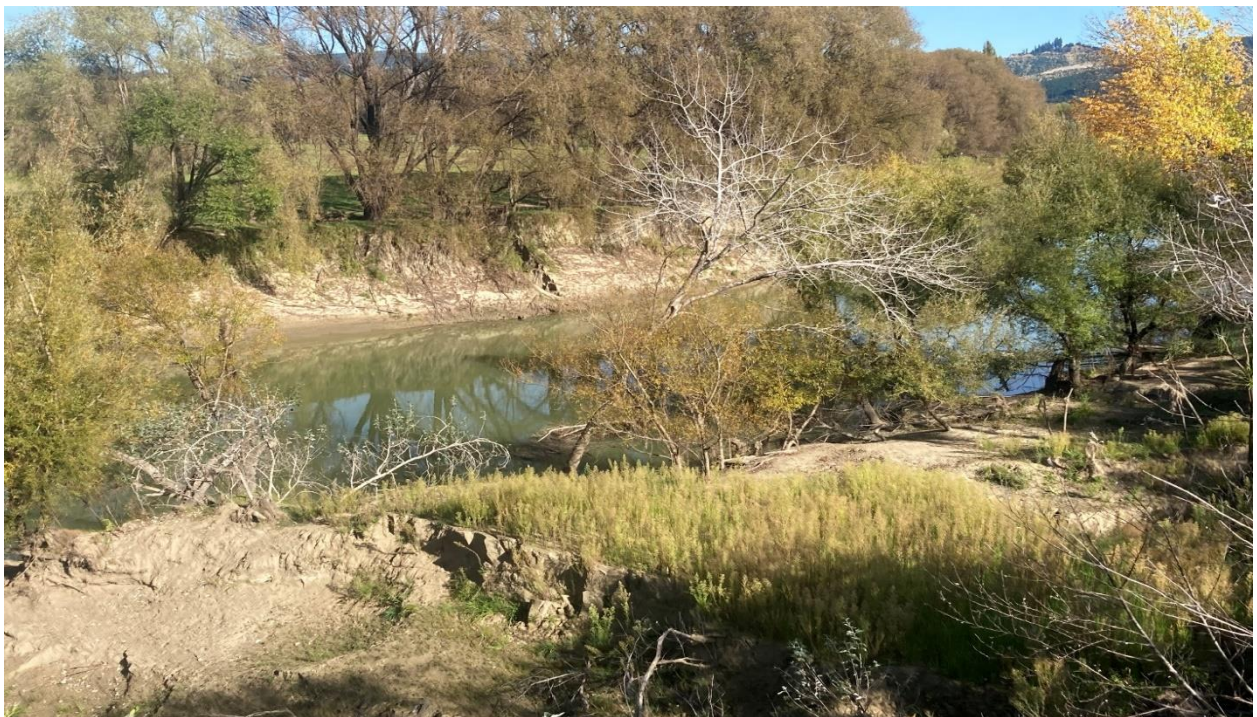
Banks on the Hikuwai River showed a high degree of stability. Where tree willows were planted at the top of the bank there was little if any slumping (Figure 24). Fibrous willow roots occupied the bank profile down to the channel. We observed large roots in the banks, partially exposed by the floodwaters, which were running laterally at different depths, and with fibrous roots extending from them (Figure 24). This was clear evidence of how willow root systems hold steep banks intact. Erosion from the top of the banks was evident where drains entered the river, and where overland flow from a low point on the paddock flowed back into the river (Figure 25). Toe erosion and slumping of the bank occurred along stretches of the river, either with no trees planted at the top of the bank, or where unsuitable trees (mānuka, poplar, tōtara) were undermined (Figure 26). At several locations, we observed that poplars planted on the top of the bank, and close to edge, were undermined and toppled by floodwaters. One example was at Hikuwai No. 1 Bridge (Figure 27).

**Figure 24.** Willows lining the top of the bank, with roots visible down the sloping bank to the channel, Hikuwai River.

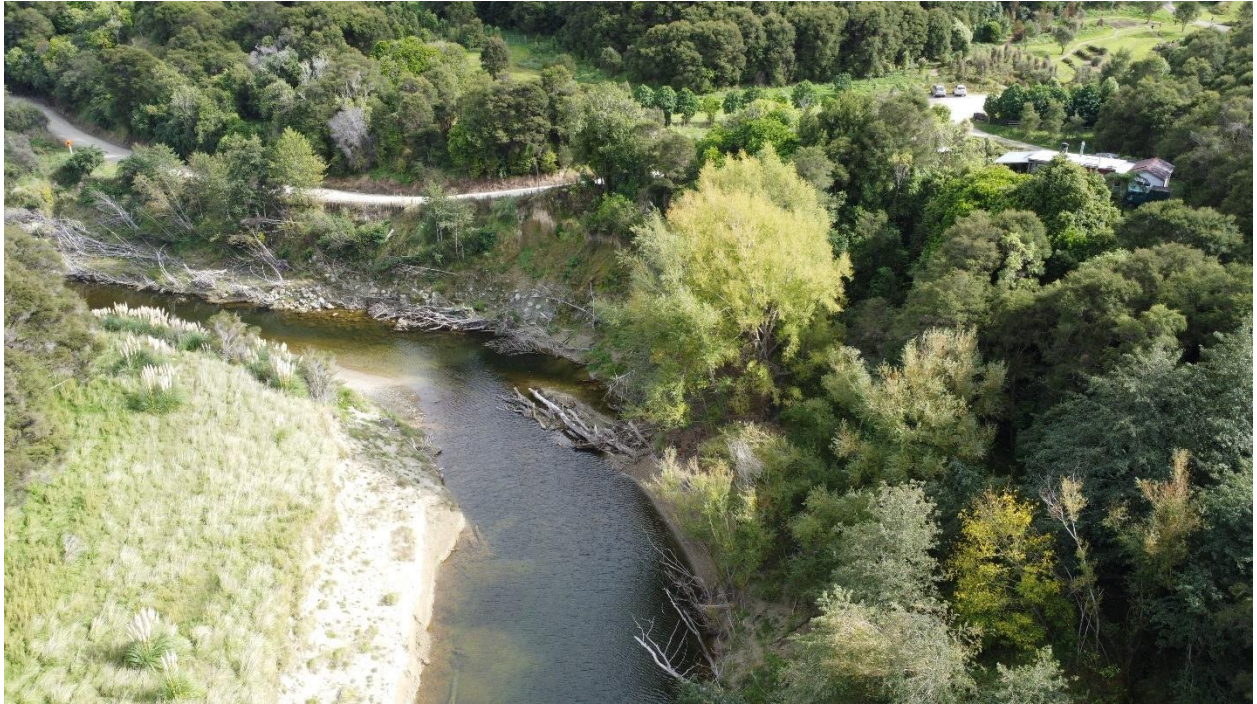
We assessed the cyclone's impact on the Waimatā River, along Riverside Road from above Donner's Bush Recreational Reserve to the outskirts of urban Gisborne. Pastoral land adjoined both sides of the river. The channel was entrenched with high banks and shallow flow. Woody debris of various types lined the channel edges. Google imagery pre- and post-flood showed substantially more loss of shrub/small tree vegetation than large trees from the riverbank. It also showed there was significant erosion on the true left bank, particularly, but not only, where there was no woody vegetation. Silver poplar (*P. alba*) trees were variously distributed along the true right bank, and there were some osier willows and tree willows. Bank erosion was generally absent where willows were concentrated (Figure 30). Mānuka trees were growing down to the edge of the steeper left bank, but this did not prevent significant erosion (Figures 31, 32). Floodwaters bent over poplars and osiers on the right bank with little resulting erosion. Woody vegetation stabilised the tributary streambanks adjacent to Caves Road but was less successful in stabilising banks of the Waimatā River. Evidence from Waimatā River observations are that mānuka root systems are inadequate to stabilise steep riverbanks in high flow events, and that poplar is not the best tree for frontline protection. The key lesson here is to use the right tree, in the right place, for the right purpose.

**Figure 30.** Tree willow on Waimatā River.

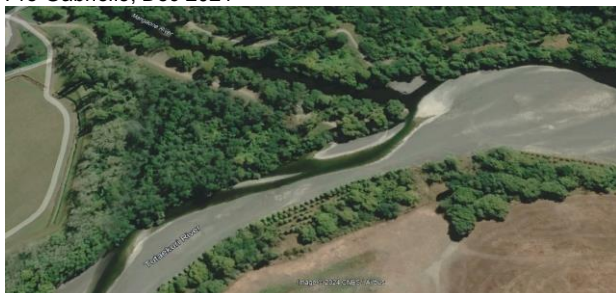
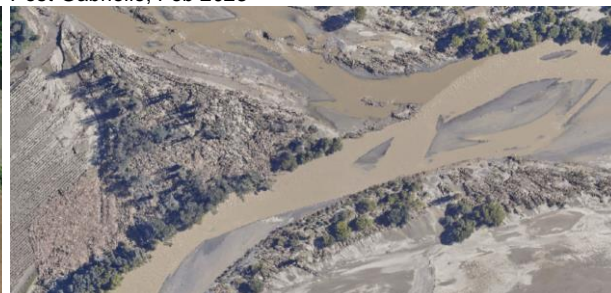
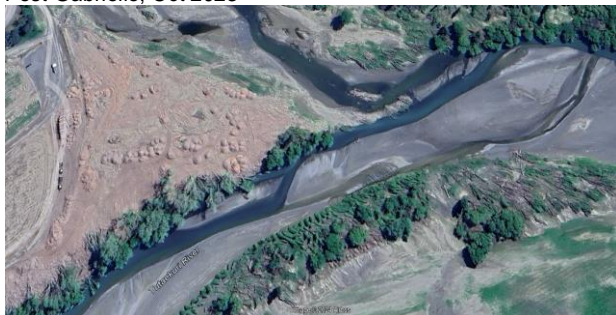
**Figure A2.** Aerial photos Tūtaekurī & Mangaone Rivers confluence site.

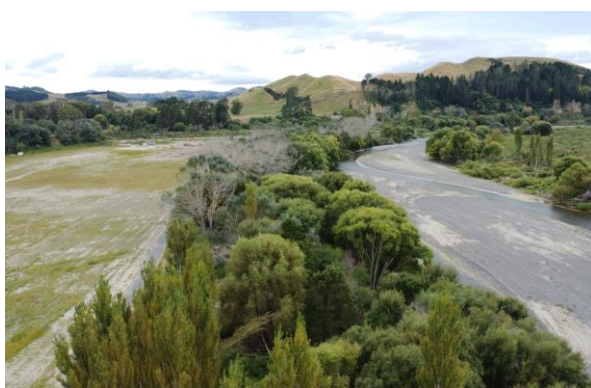
**Figure A3.** Buffer zone planting.

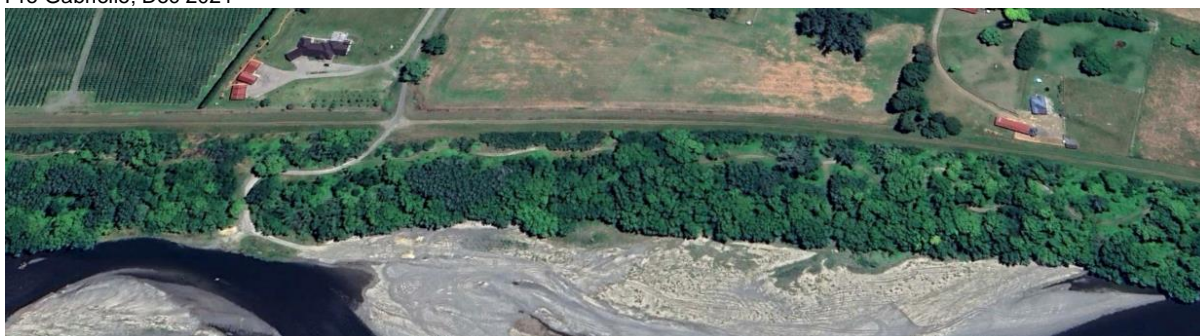
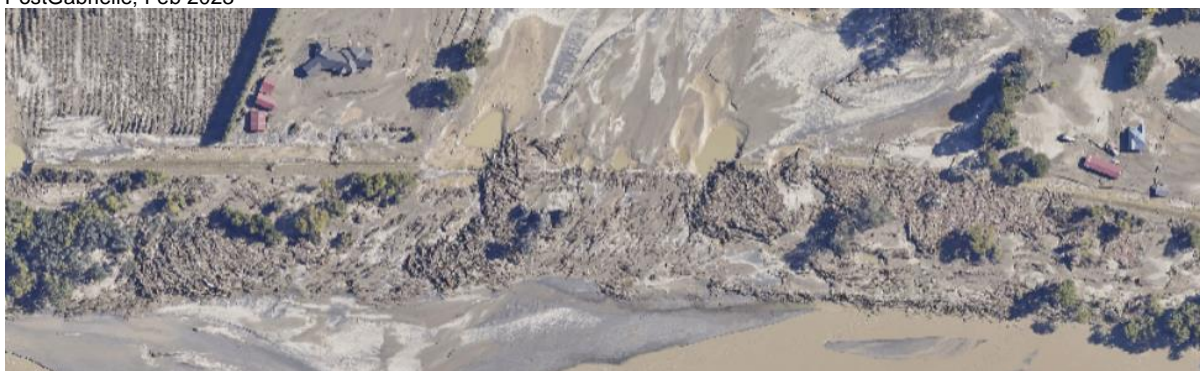
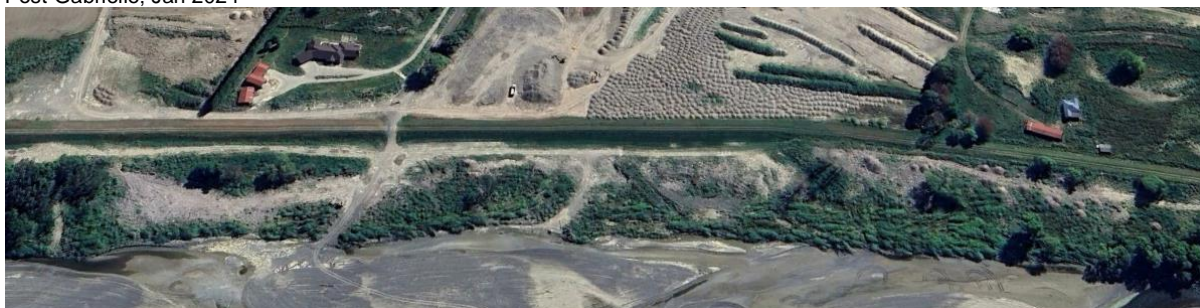
The buffer plantings upstream and downstream of the site were in very good condition, and showed exceptional resilience to the flood event, mainly due to berm flows running parallel to the river.

**Figure A11.** Directional effect of Ebbetts floodplain return flows & Dartmoor stopbank breach flows.

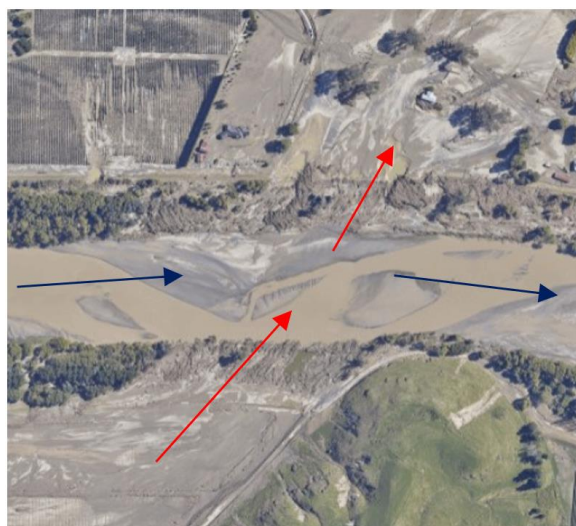
**Figure A12.** Directional flow of floodwater from Ebbetts across the channel to lower Dartmoor.

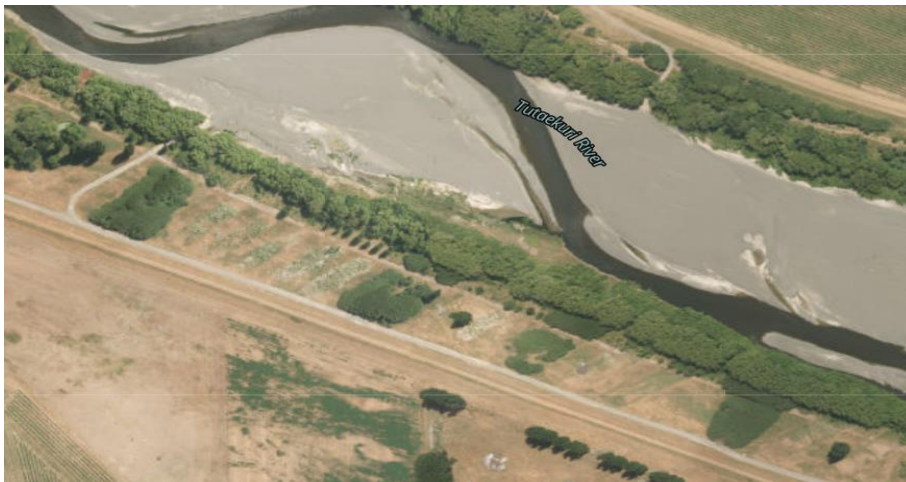
**Figure A13.** Pre-cyclone berm with buffer zone & chevron planting.

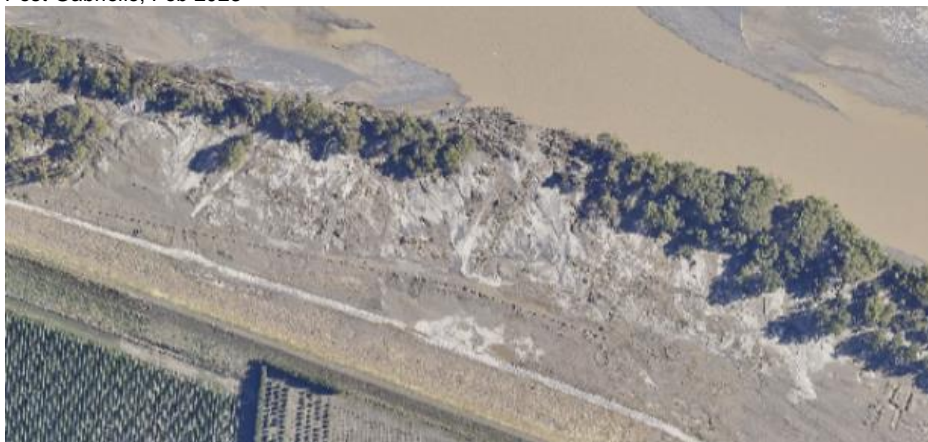
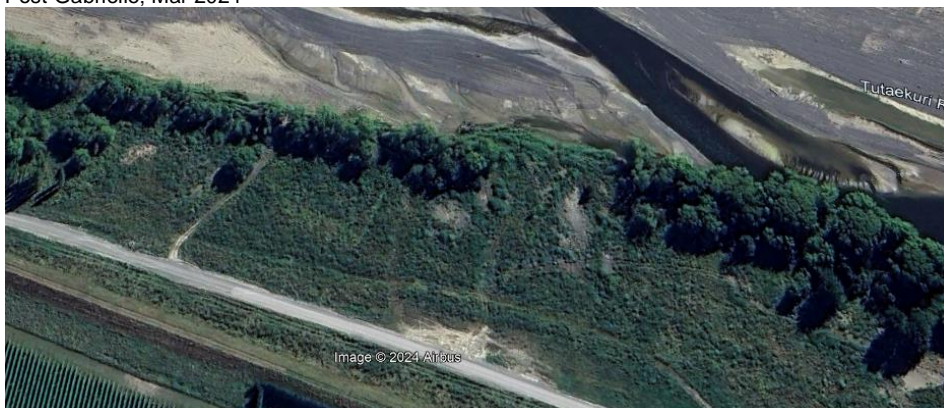
Of particular note was the effectiveness of the buffer zone, adjacent to the major Moteo stopbank breach, in preventing the berm scour hole from connecting with the river channel. Such a connection would have increased berm and stopbank flood damage and resulting damage to floodplain property.

**Figure A14.** Aerial views of the Moteo site pre- and post-Gabriel.

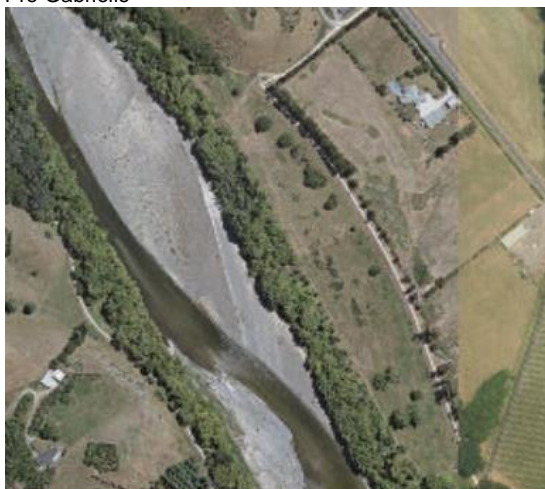
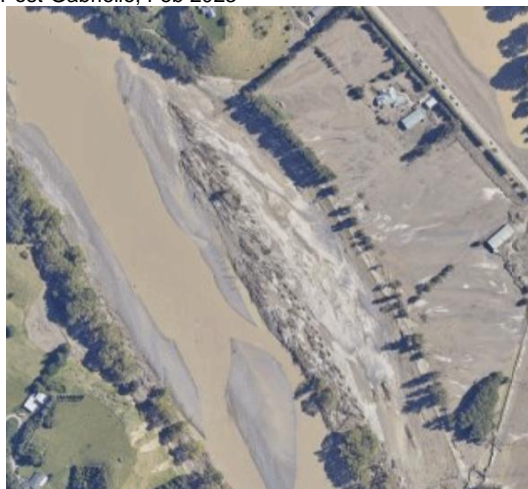
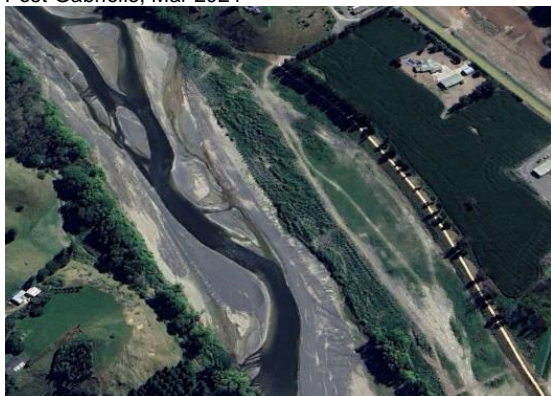
Post cyclone, the flood layered bank and berm vegetation showed strong regrowth. The upstream end of the site was strengthened with rope and rail groynes, willow trenching, and pole planting. Willow pole planting was also carried out to widen and infill open areas of the buffer. This work was establishing well.

**Figure A16.** Aerial views of the Puketapu site pre- and post-Gabriel.

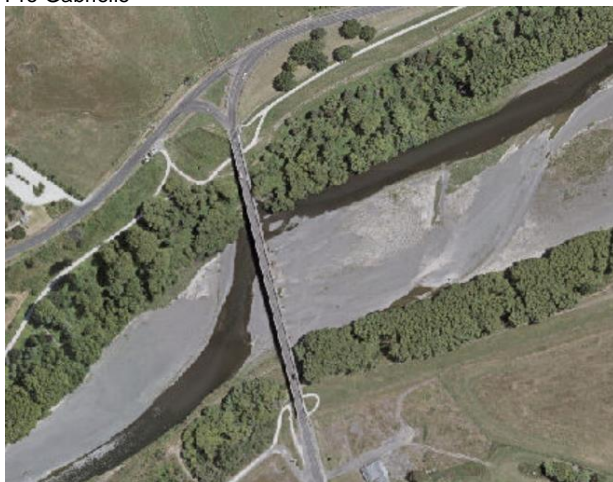
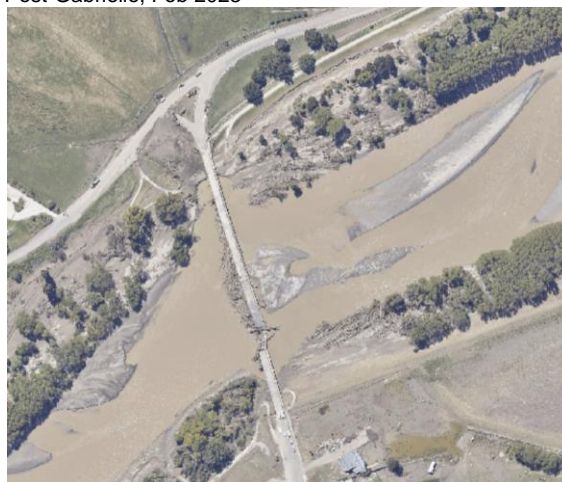
There was substantial bank and berm erosion upstream at both ends of the bridge. Berm erosion also occurred adjacent to the newly upgraded Taradale stopbank. Fortunately these erosion sites didn't grow and cause bridge abutment washout or stopbank breach.

**Figure A20.** Aerial views of the Redclyffe Bridge.

Post-cyclone repairs undertaken included debris removal from the bridge and channel, interim bridge repairs, scour hole filling on the banks and berms, and willow pole planting. Substantial further work will be needed to secure this vulnerable site.

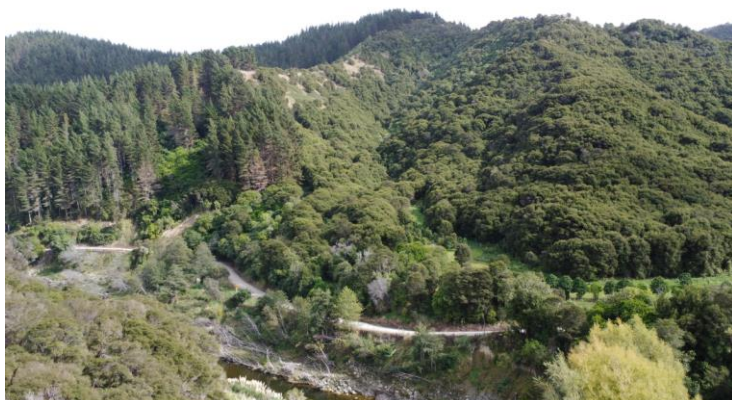
**Figure A26.** Hill slope vegetation contrast – forestry and native regeneration – Waimatā River.

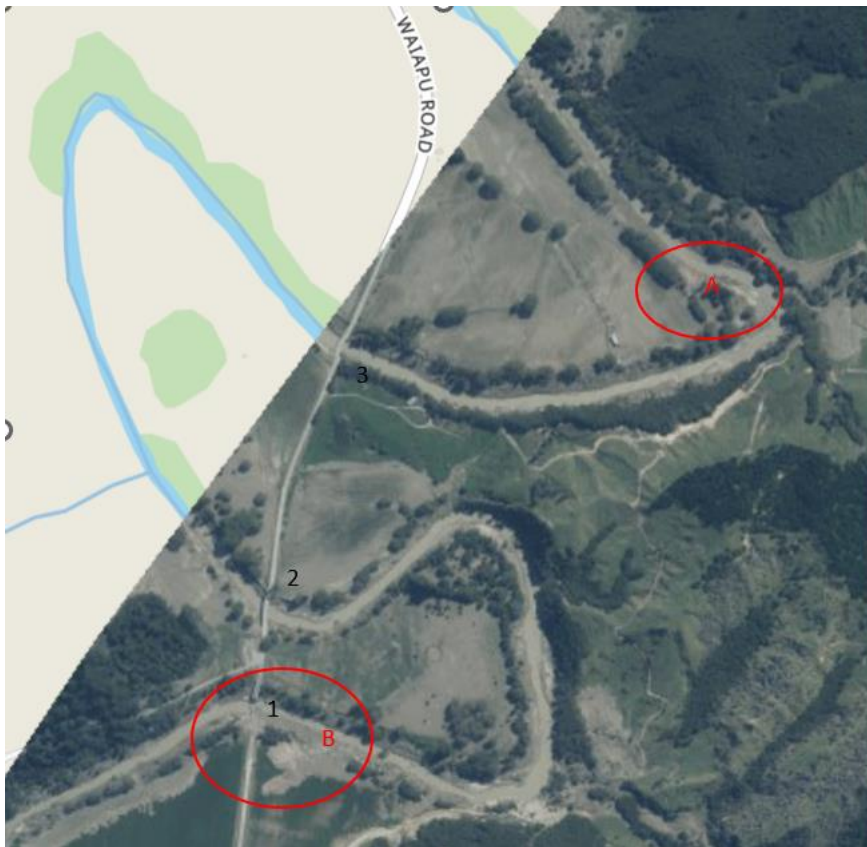
Within Tairāwhiti there were a number of instances where woody debris capture on river berms and floodplain areas reduced downstream movement of flood debris. This was a fortuitous outcome of berm tree location and alignment in relation to in-river and overland flow patterns. In the case of the Hikuwai River there were two sites, upstream of Hikuwai Bridges No. 3 & No. 1, where significant volumes of debris accumulated (see Figures A28 & A29).

**Figure A28.** Hikuwai River – woody debris capture sites.

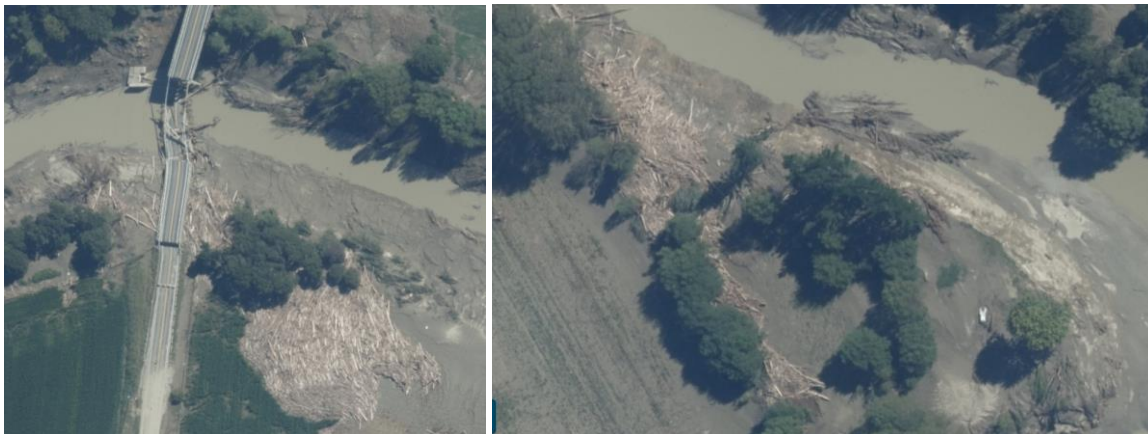
**Figure A29.** Hikuwai River – woody debris capture – Sites A & B.
